# Manhole Inspection Summary

Manhole # S11Y\_\_010MH

Insp Date: **12/11/08 11:36 AM**

**Location** Address: **1202 S Caton Ave**

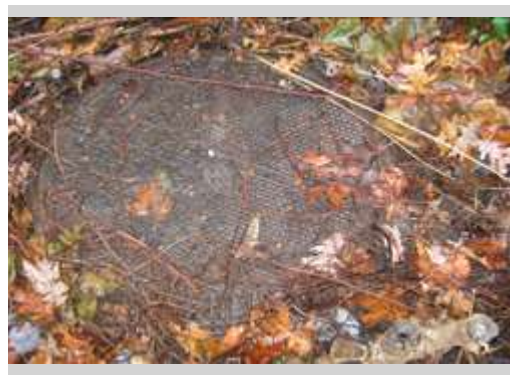
Misc

MH cover

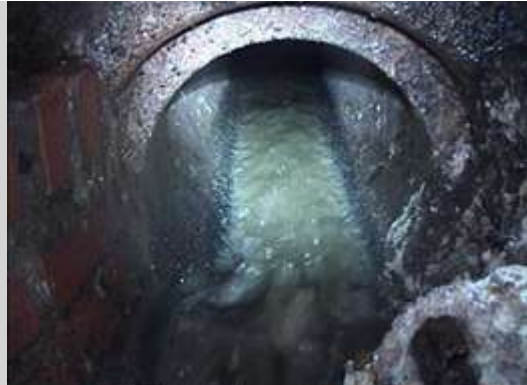
12 O'Clock Outflow

Pipe Height: **15.6** (in.) Rod and Bar (Angled)  
Pipe Material: **Clay** ☐ Pipe Lined  
Invert Depth: **19.73** (ft.) Flow Characteristics: **Fast**  
Deposits: ☒ None ☐ Mud ☐ Sludge ☐ Debris ☐ Grease  
Silt Depth: **0** (in.) Deposits Extent:  
Infiltration: **None** Pipe Seal Cond: **Sound**

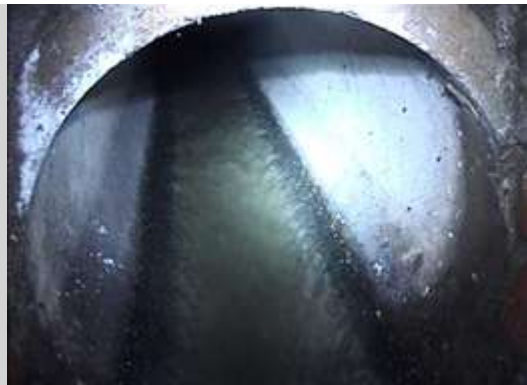
5 O'Clock Inflow

Pipe Height: **15.6** (in.) Rod and Bar (Angled)  
Pipe Material: **Clay** ☐ Pipe Lined  
Invert Depth: **19.57** (ft.) Flow Characteristics: **Fast**  
Deposits: ☒ None ☐ Mud ☐ Sludge ☐ Debris ☐ Grease  
Silt Depth: **0** (in.) Deposits Extent:  
Infiltration: **None** Pipe Seal Cond: **Sound**

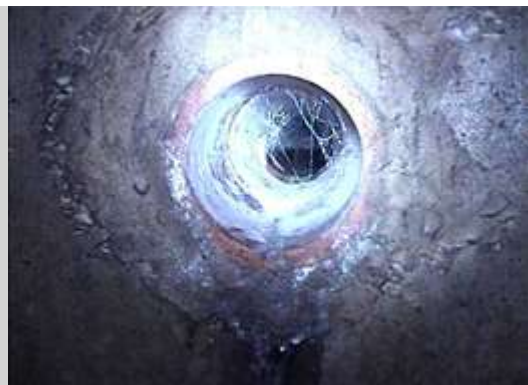
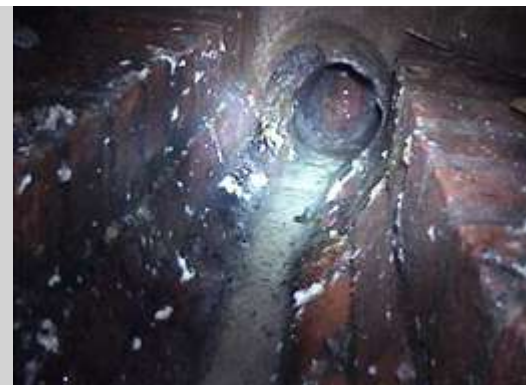
7 O'Clock Inflow

Drop: <b>Inside</b>	Rod and Bar
Angled: <b>Yes</b>	Reading: <b>17.70</b> (ft.)
	Inv Depth: <b>18.70</b> (ft.)
Drop Condition: <b>Open</b>
